## **CITY OF CHICAGO**

# **WINDOW EVALUATION AND MITIGATION VINYL ACOUSTICAL WINDOWS CHICAGO, IL**

**PROJECT NUMBER**  
I1935.01-601-17 R0

**ISSUE DATE**  
07/19/18

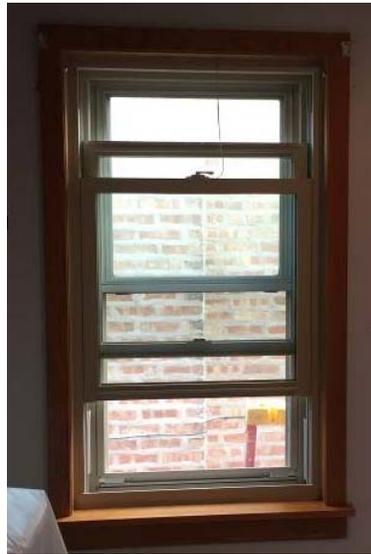
**Photo No. 1**  
Interior view of typical double-hung window.

In general, the majority of the Sound Solutions acoustical windows are vinyl double-hung windows (*reference Photo Nos. 1 and 2*). The typical double-hung window system consist of an inner operable window system with insulated glass units, and an integral outer operable storm window (single pane glass). A framed screen is located between the inner window and storm window (*reference Photo No. 3*). The framing of the inner window is vinyl and the integral storm window is aluminum. Large weeps are present through the sill framing (between the inner window and storm window) to drain water leakage.

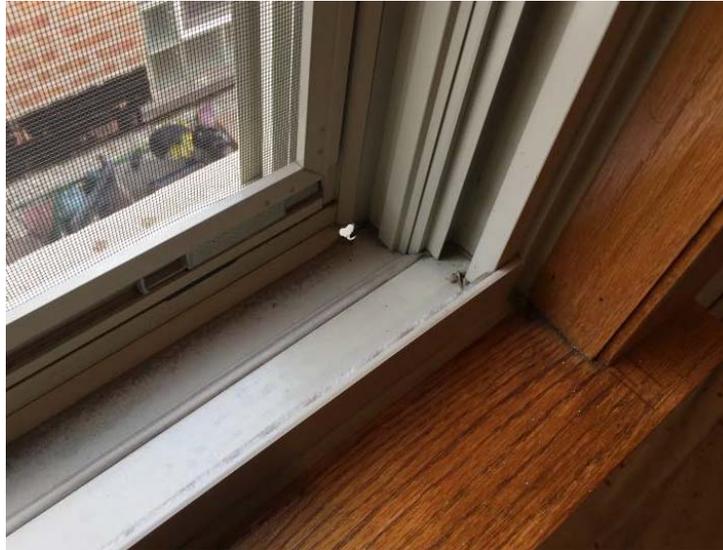
**Photo No. 3**

While the cause of the screen deterioration is not completely understood, the dynamics of most acoustical windows are different than conventional windows, making the durability of the screen material more important. For conventional non-acoustical windows, where the screen is completely outboard of the system, if the screen material deteriorated and off-gassed, the odor would dissipate and likely be not noticed by residents. The screen in the Sound Solutions windows is located between two systems (inner window and storm window). Further, in many instances the airtightness performance is relatively good. Therefore, the odor can become trapped and concentrated within the system, and not noticed by residents until the inner window sash is opened, releasing the odorous air into the residence. However, because all windows (including new) have acceptable levels of air leakage, windy or other conditions that create pressure differential across the inner window can cause infiltration of odorous air into the residence even when the windows are closed and secured.

**Typical screen location for double-hung windows.**

In addition to performing the mitigation evaluation noted above, we recommend that potential replacement window screen materials be tested to ensure durability, confirm odors are not created under service conditions, etc. Following the mitigation evaluation noted above, assuming acceptable results (i.e. no odors smelled), follow-up evaluation with replacement screens in place should be considered.

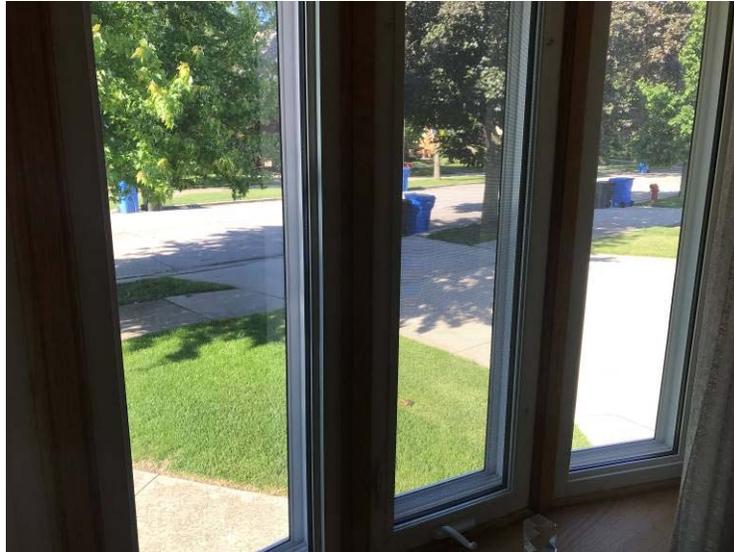
**Photo No. 4**

Other window types include casements (*reference Photo No. 4*), where the screen is located inboard of the inner insulated window, with the storm window integrated with the face of the inner window (*reference Photo No. 5*).

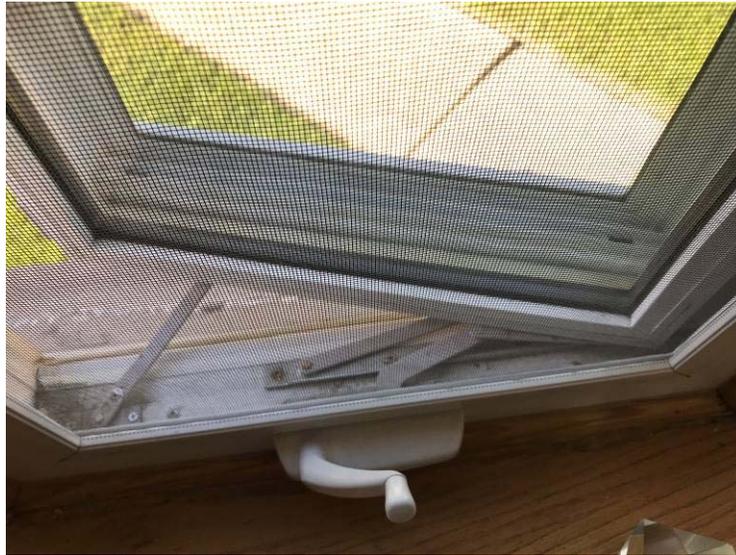
**Photo No. 5**

**Typical screen location for casement windows.**

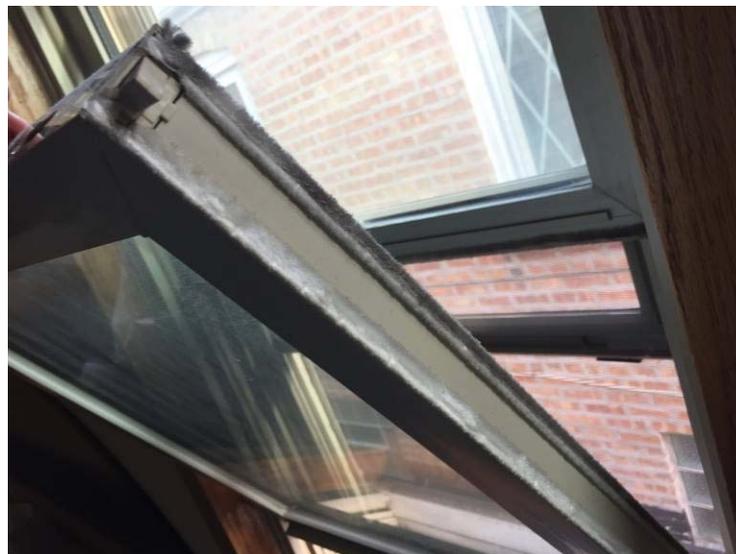
**Photo No. 6**

Due to the reported odors, observations were primarily focused on the double-hung windows. The windows reviewed include tilt-in features, commonly marketed for ease of cleaning the exterior glass surfaces. Brush-type weatherstripping is typically attached to the ends of the operable sash and other locations, to create air and water seals. In general, the weatherstripping reviewed appears continuous and intact (*reference Photo Nos. 6 and 7*). Most of the sash were relatively "tight" within the frame; however, we did note isolated windows where the sash was relatively loose, with one area where daylight was visible between the sash and frame.

**Typical condition of brush-type weatherstripping.**

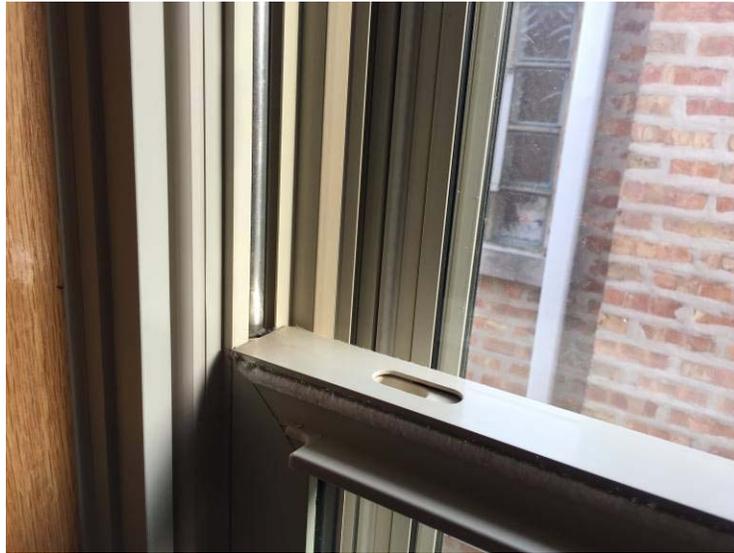
**Photo No. 7**

**Typical condition of brush-type weatherstripping.**
